**Flood Control Project Maintenance  
Levee Inspections****LMA District Cover Sheet****Spring 2012 Levee Inspection Results****Reclamation District No. 0017 Mossdale**

**Spring 2012 Levee Inspection Results**

**Reclamation District No. 0017 Mossdale**

Waterway			Bank	Unit Miles
Unit No. 01 French Camp Slough			Left	1.79
	Spring (March - May)	Summer (June - August)	(September - November) Fall	Winter (December - February)
Unit Maintenance Rating (Fall Only)				
Date of Inspection	3/27/2012 - 3/27/2012			
DWR Inspector	Richard Willoughby			
Accompanied By	Robert Winter KSN Engineering

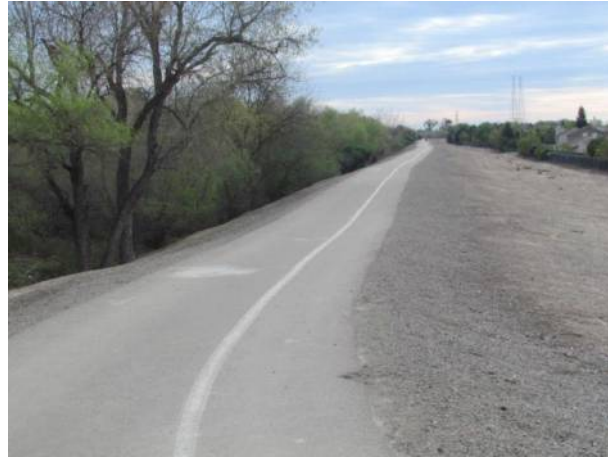
Levee Mile Report Line	4
Start Levee Mile	0.00
End Levee Mile	1.78
Location	Land Side
Category	Earthen Levee
Item	Vegetation

Looking south at typical view of landside and waterside of levee.

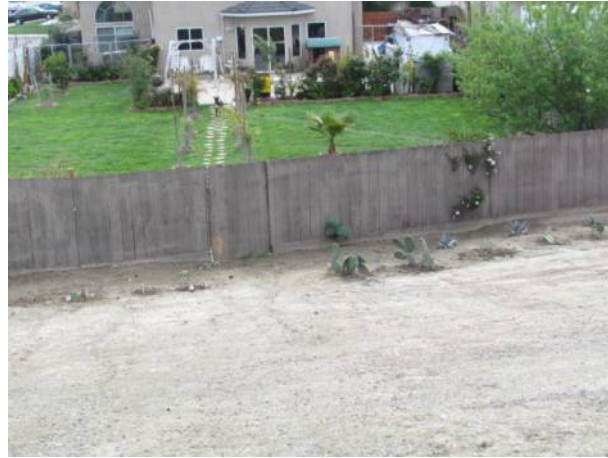
Levee Mile Report Line	5
Start Levee Mile	0.83
End Levee Mile	0.83
Location	Land Side
Category	Earthen Levee
Item	Encroachments

DWR ID: DWR_RD0017_02_s_2012_8										
5	0.83	0.83	Earthen Levee	Encroachments	LS En	M	CR : Crops Inspector Comments: New cactus plantings at landside toe of levee eight feet from landowner fence.	37.905372 ° -121.322727 °	37.905372 ° -121.322727 °	10 Y
DWR ID: DWR_RD0017_02_s_2012_10										
6	1.19	1.19	Earthen Levee	Encroachments	LS En	M	PR : Prunings	37.901047 ° -121.325525 °	37.901047 ° -121.325525 °	12 Y
DWR ID: DWR_RD0017_02_s_2012_12										
7	4.24	4.27	Earthen Levee	Vegetation	LS En	M	V6 : Landscaping	37.863819 ° -121.320784 °	37.863601 ° -121.320299 °	48 Y
DWR ID: DWR_RD0017_02_s_2012_48										
8	4.28	4.32	Earthen Levee	Encroachments	LS En	U	CR : Crops	37.863582 ° -121.320230 °	37.862947 ° -121.319812 °	11 Y
DWR ID: DWR_RD0017_02_s_2012_11										
9	4.42	4.44	Earthen Levee	Vegetation	LS En	U	V6 : Landscaping	37.861673 ° -121.320115 °	37.861370 ° -121.320102 °	1 Y
DWR ID: DWR_RD0017_02_s_2012_1

Looking west at new cactus plantings on landside toe.

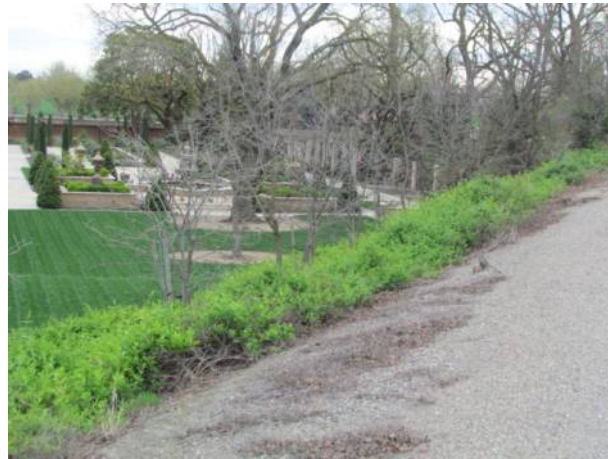
Levee Mile Report Line	7
Start Levee Mile	4.24
End Levee Mile	4.27
Location	Land Side
Category	Earthen Levee
Item	Vegetation

Looking southeast at dense ground cover on landside slope.

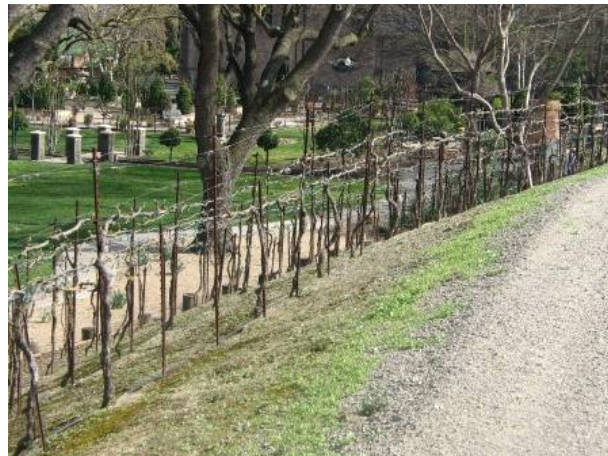
Levee Mile Report Line	8
Start Levee Mile	4.28
End Levee Mile	4.32
Location	Land Side
Category	Earthen Levee
Item	Encroachments

Grape vines on landside slope from LM 4.28 to 4.32

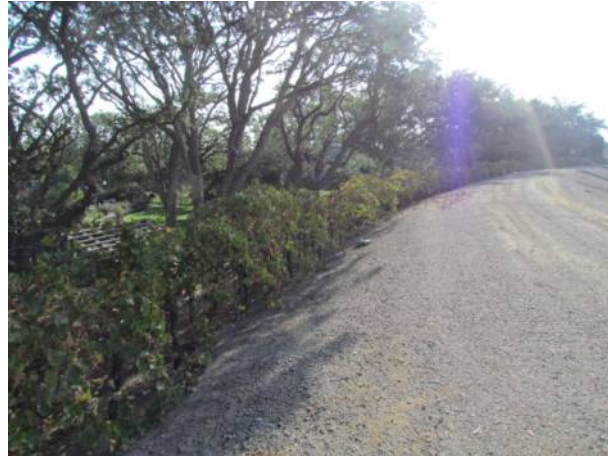
Levee Mile Report Line	8
Start Levee Mile	4.28
End Levee Mile	4.32
Location	Land Side
Category	Earthen Levee
Item	Encroachments
Looking southeast at grape vines on landside slope	
richard_s_20120313_634.jpg

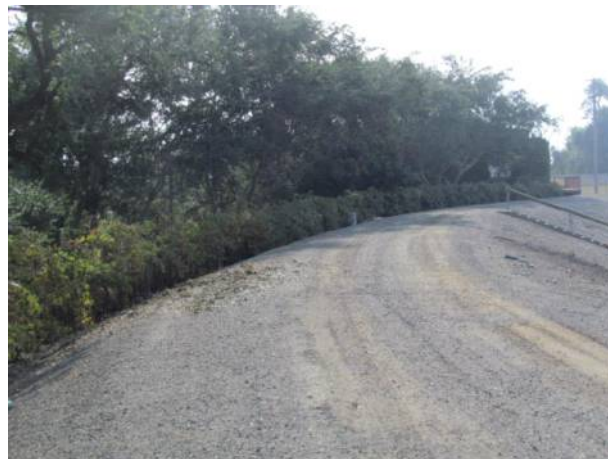
Levee Mile Report Line	8
Start Levee Mile	4.28
End Levee Mile	4.32
Location	Land Side
Category	Earthen Levee
Item	Encroachments
Looking south at landscaping with grape vines on landside slope	
richard_s_20120313_635.jpg

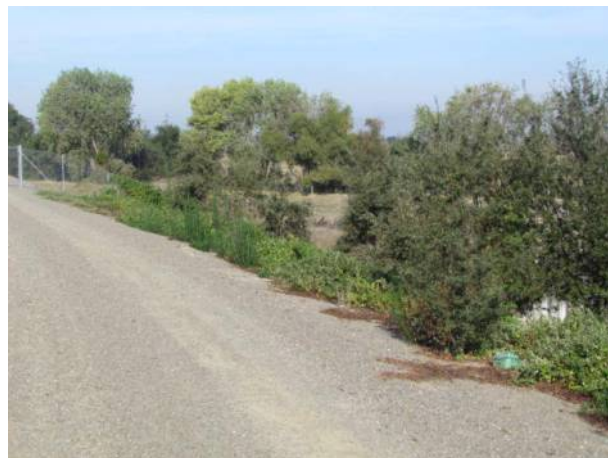
Levee Mile Report Line	8
Start Levee Mile	4.28
End Levee Mile	4.32
Location	Land Side
Category	Earthen Levee
Item	Encroachments
Looking northeast at dense landscaping on landside slope.	
richard_s_20120313_636.jpg

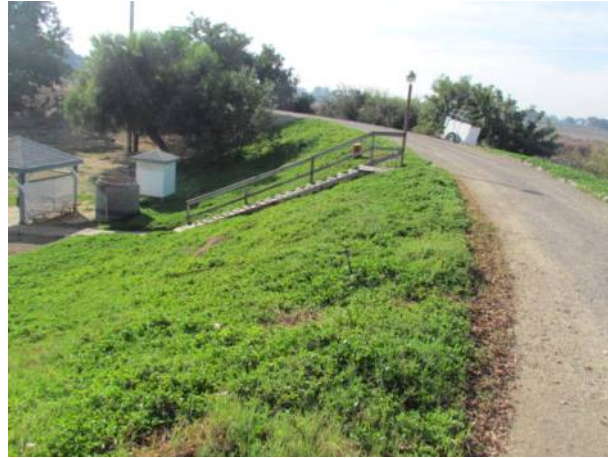
Levee Mile Report Line	9
Start Levee Mile	4.42
End Levee Mile	4.44
Location	Land Side
Category	Earthen Levee
Item	Vegetation
Looking southeast at ground cover on landside slope.	
richard_s_20120313_631.jpg

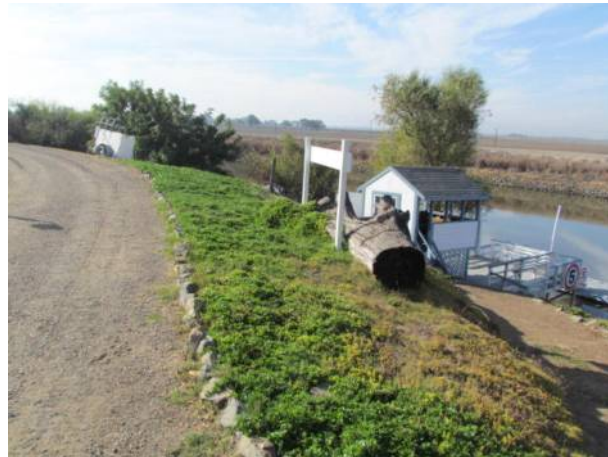
Levee Mile Report Line	9
Start Levee Mile	4.42
End Levee Mile	4.44
Location	Land Side
Category	Earthen Levee
Item	Vegetation
Looking southwest at landscaping and boat dock on waterside slope and channel.	
richard_s_20120313_632.jpg

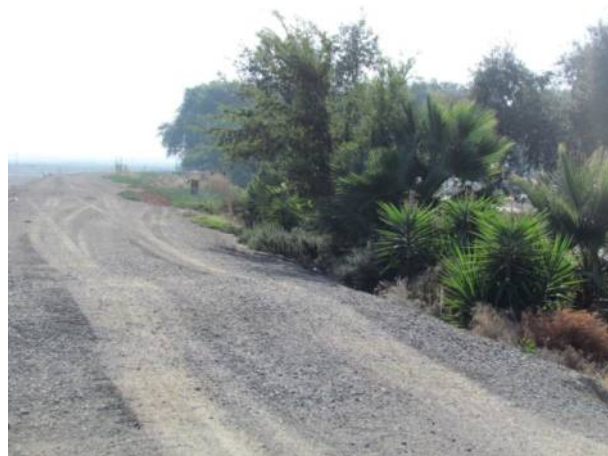
Levee Mile Report Line	14
Start Levee Mile	5.62
End Levee Mile	5.85
Location	Land Side
Category	Earthen Levee
Item	Vegetation
Looking south at overgrown landscaping on waterside slope.	
richard_s_20120313_638.jpg

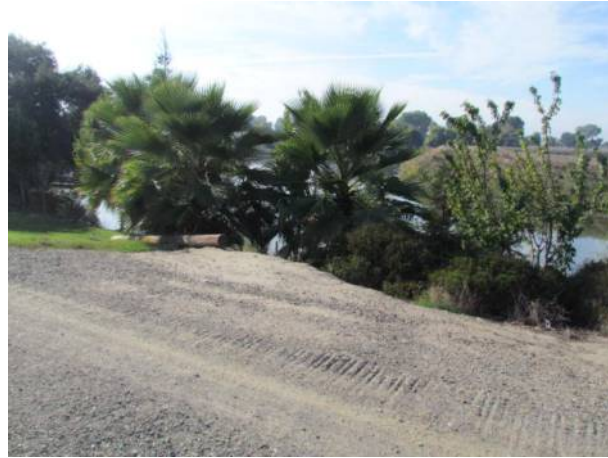
Levee Mile Report Line	14
Start Levee Mile	5.62
End Levee Mile	5.85
Location	Land Side
Category	Earthen Levee
Item	Vegetation

Looking west at landscaping on waterside slope.

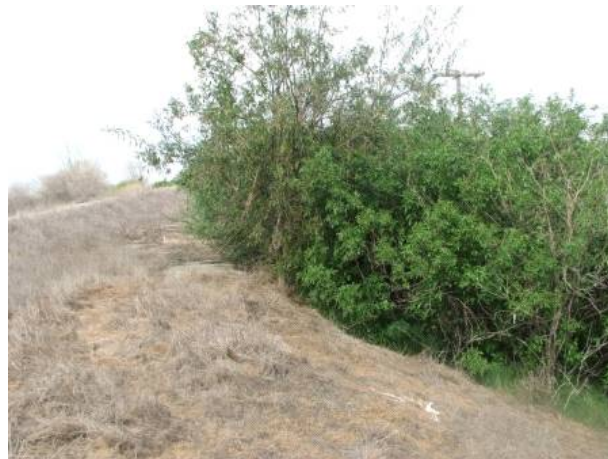
Levee Mile Report Line	18
Start Levee Mile	7.67
End Levee Mile	7.69
Location	Land Side
Category	Earthen Levee
Item	Vegetation

Elderberry blocking view of landside slope and toe from LM 7.67 to 7.69
